**Re: Albany County Septic System Impact Assessment
Final Reports - Wenck Project – B7218-0001 WYALB101**

ALBANY COUNTY SEPTIC SYSTEM IMPACT ANALYSIS

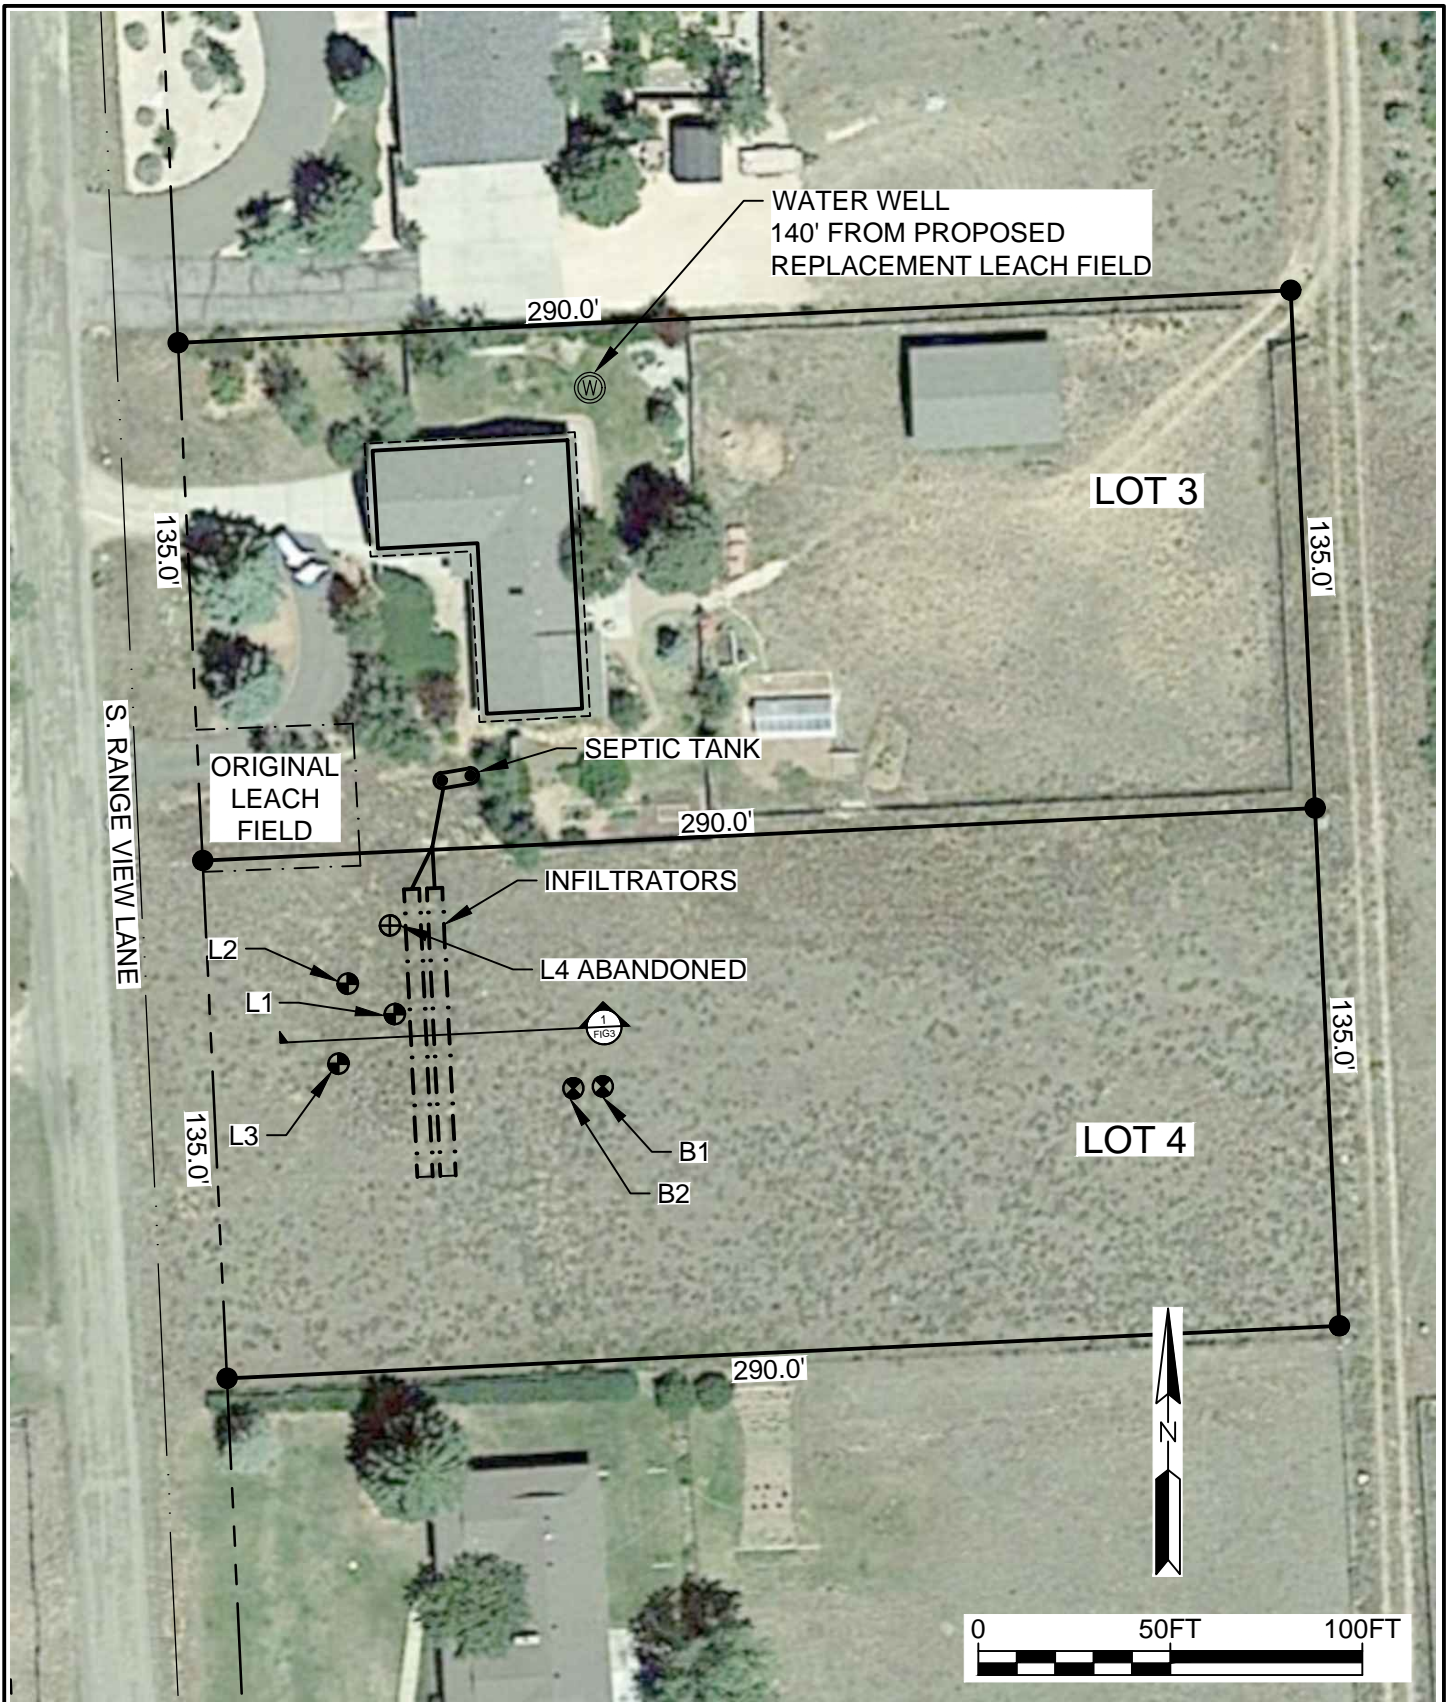
At the locations shown on **Figure 2**, two test holes, B-1 and B-2, were drilled on February 12, 2018, east of the septic system. Groundwater was not encountered in either test hole. Both of these holes were drilled outside the septic system footprint. B-1 was drilled to initially assess the subsurface conditions. B-2 was drilled to determine the thickness and composition of the soil, unconsolidated sand, and Casper Formation material; obtain samples of the unconsolidated sand and Casper Formation; and evaluate shallow groundwater conditions close to the septic system. Because groundwater was not encountered in either test hole, monitoring wells were not installed. Given the reported depth to water in the residential well, the Casper Aquifer (saturated Casper Formation) underlies the site, but the depth at which groundwater would have been encountered is uncertain. Wenck discussed the possibility of completing a monitoring well west and downgradient of the septic system to monitor nitrate concentrations in near surface groundwater, but Albany County and the City of Laramie opted not to pursue its completion. Lithologic logs of these two test holes are included in **Appendix C**.

As shown on **Figures 2 and 3**, four lysimeter holes were drilled west of the western infiltrator at the site for the vadose zone monitoring network. Between February 13 and 14, 2018, Authentic completed the installation of the lysimeters in L-1 through L-4. L-4 was drilled first but was plugged and abandoned after damaging the western infiltrator. All In One Septic Systems and Plumbing Service (All In One) excavated and repaired the damaged infiltrator after the other lysimeters had been installed. The lysimeter holes were drilled with new 8.25-inch diameter hollow stem augers that had not been used prior to this project. Each auger was decontaminated between holes. Bulk soil samples from each lysimeter hole (L-1 through L-3 only) were also collected for laboratory testing and analysis. At L-1 and L-2 beneath approximately 1 foot of silty sand or sandy silt soil, unconsolidated sand of the alluvial fan deposits was encountered to the bottom of each lysimeter hole as shown on **Figure 3**. L-1 was completed with lysimeters set at vertical depths of 5 and 12 feet below ground surface in the unconsolidated sand. L-2 was completed with lysimeters set at depths of 19 and 25 feet, respectively, in the unconsolidated sand. However, the lysimeter at 25 feet was set at or near the interface between the unconsolidated sand and Casper Formation. At L-3, similar sediments were observed to a depth of 33 feet, at which point a

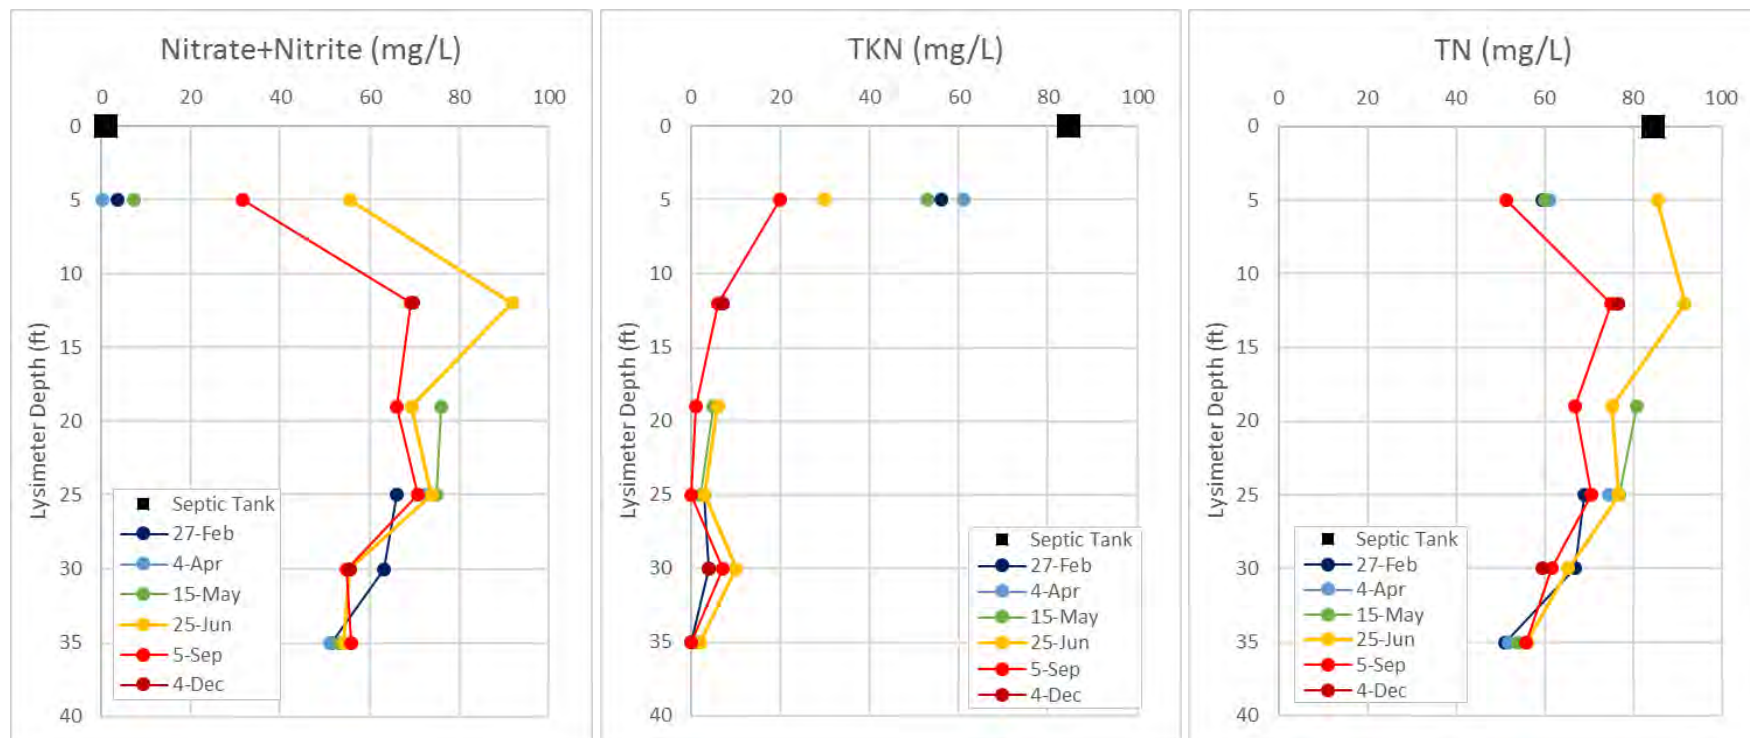
Figure 4: Lysimeter Moisture Quality Depth Profiles

As discussed in the previous section, nearly all of the nitrogen in the septic tank is in ammonia form prior to being discharged to the infiltrators. The lysimeter profiles shown on **Figure 4** indicate that TKN concentrations decrease significantly in the top 12-feet of the vadose zone as the average TKN concentration (all sample events) for the lysimeter located 12-feet below grade is approximately 92% lower (6.5 mg/L) than the average TKN concentration in the septic tank (84.5 mg/L). TKN levels continue to decrease between the 12-foot and 35-foot lysimeters, however, not as dramatically as the TKN decrease in the upper 12 feet of the vadose zone. Average TKN concentrations decrease from 6.5 mg/L at the 12-foot lysimeter to 0.8 mg/L at the 35-foot lysimeter, suggesting nitrification and/or ammonia adsorption continues to occur throughout this part of the vadose zone.

The lysimeter profiles also indicate that the TKN changes in the upper 12-feet of the vadose zone coincide with significant increases in nitrate+nitrite concentrations. As discussed in Section 5.1, nitrate+nitrite concentrations in the septic tank were below laboratory reporting limits. Nitrate+nitrite concentrations for the samples collected within the unconsolidated sand at the 5-foot and 12-foot lysimeters averaged 19.6 mg/L and 76.9 mg/L, respectively. These increases indicate a majority of the TKN (i.e. ammonia) discharged from the septic tank is adsorbed to the soil and/or converted to nitrate in the upper 12-feet of the vadose zone. The data shows these processes occur more rapidly in the upper 5-feet of the vadose zone during the warmer summer months, because the June and September nitrate+nitrite samples (55.6 mg/L and 31.5 mg/L) were significantly higher than the nitrate+nitrite samples collected in the 5-foot lysimeter in February, April, and May (3.6 mg/L, 0.2 mg/L and 7.1 mg/L, respectively).

The lysimeter profiles show that nitrate+nitrite levels begin to decrease in the deeper part of the vadose zone below 12 feet. Average nitrate+nitrite concentrations go from 76.9 mg/L at the 12-foot lysimeter to 53.1 mg/L at the 35-foot lysimeter (~31% reduction), suggesting that some denitrification and/or dilution with non-septic water occurs as water moves through this portion of the vadose zone. Unlike the upper vadose zone, the TKN and nitrate+nitrite changes in the deeper vadose zone appear to be relatively consistent between the six sample events which suggests that denitrification rates in the lower vadose zone are relatively consistent throughout the year. Nitrate concentrations in the upper 10 feet of the Casper Formation (i.e. lysimeter depths 30 and 35 feet) range from 51 to 63 mg/L.

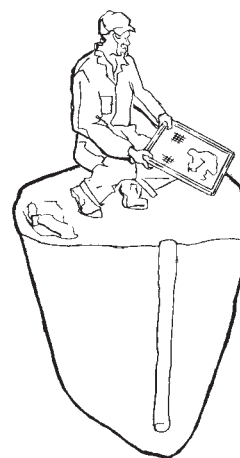
Figure 4a.

Figure 4b.

In rock-free, uniform soils at shallow depths, use a 2-inch screw or bucket auger for coring the hole (Figure 4a). If the soil is rocky, a 4-inch auger should be used. The soil is then sifted (Figure 4b) through a 2mm mesh screen or 2mm sieve to free it of pebbles and rocks.
